Reactivation of old landslides: lessons learned from a case-study in the Flemish Ardennes (Belgium)

M. VAN DEN EECKHAUT¹, J. POESEN¹, O. DEWITTE², A. DEMOULIN², H. DE BO¹ & M. C. VANMAERCKE-GOTTIGNY¹

Keywords: Old deep-seated landslide, landslide reactivation, anthropogenic causal factors, land-use change, damage

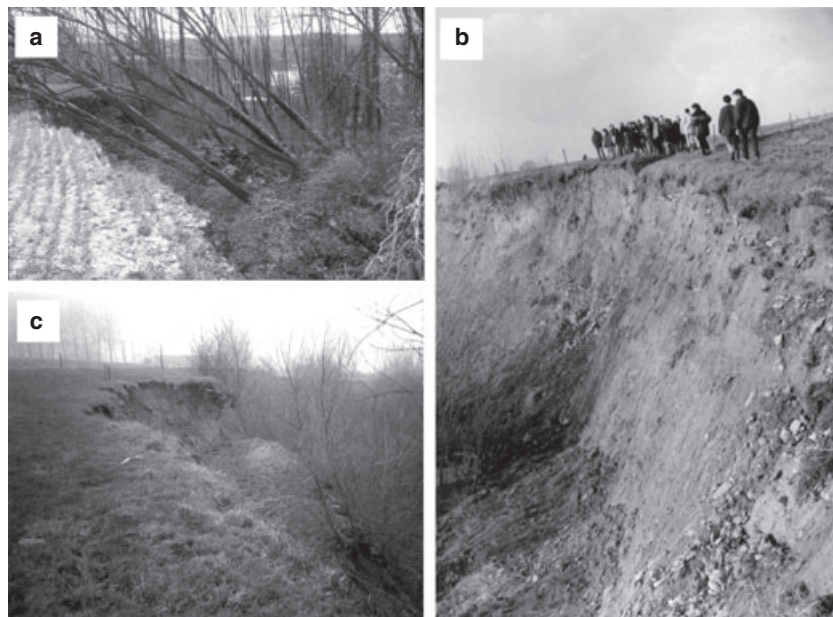
Figure 2 The Hekkebrugstraat landslide: (a) main scarp retreat in February 1995. The loading of the tilted block, indicated by tilted poplar tree stems, reactivated the debris in the accumulation zone. Note the sealed soil surface upslope of the main scarp producing large volumes of surface runoff during the prolonged rainfall events in the winter of 1994–1995; (b) 8-m-high main scarp in March 1999 (photo by J. Reyniers); (c) main scarp retreat in January 2003.

high February rainfall (115.3 mm) was responsible for the reactivation of the movement in the affected area. By the end of February, the Hekkebrug road was destroyed (Figure 6c,d). The asphalt, stone bricks and drainage pipes had been pushed several metres downslope. Apart from the Hekkebrugstraat landslide, at least three other large, deep-seated landslides were reactivated in the Flemish Ardennes during the wet spring of 1995.

To the present day, it seems that the drainage trenches in the wood have drained most of the water from the affected area to the Marke brook because little movement has been observed in the accumulation area since 2001. However, the main scarp has not yet stabilized because both in March 2002 and in January 2003 slices of about 15 m long and 3 m wide fell from the main scarp (Figure 2c). Especially for the January 2003 event (Table 3),

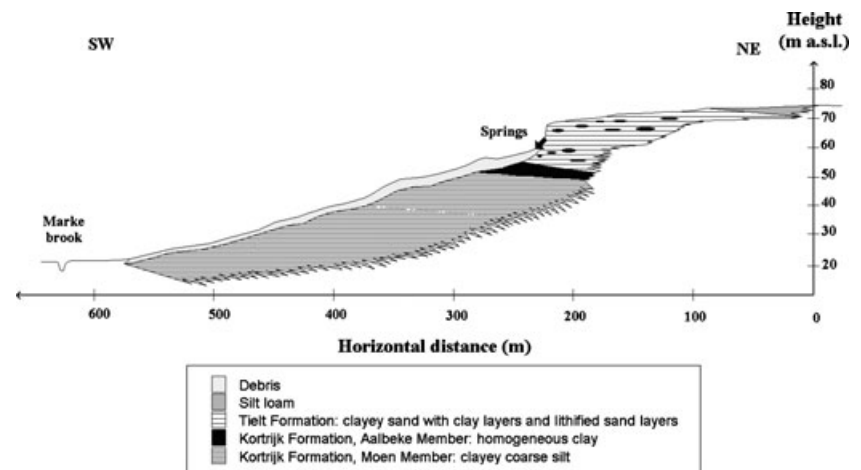
Figure 3 Cross-section through the Hekkebrugstraat landslide with indication of the lithology (after Gulinck, 1966).

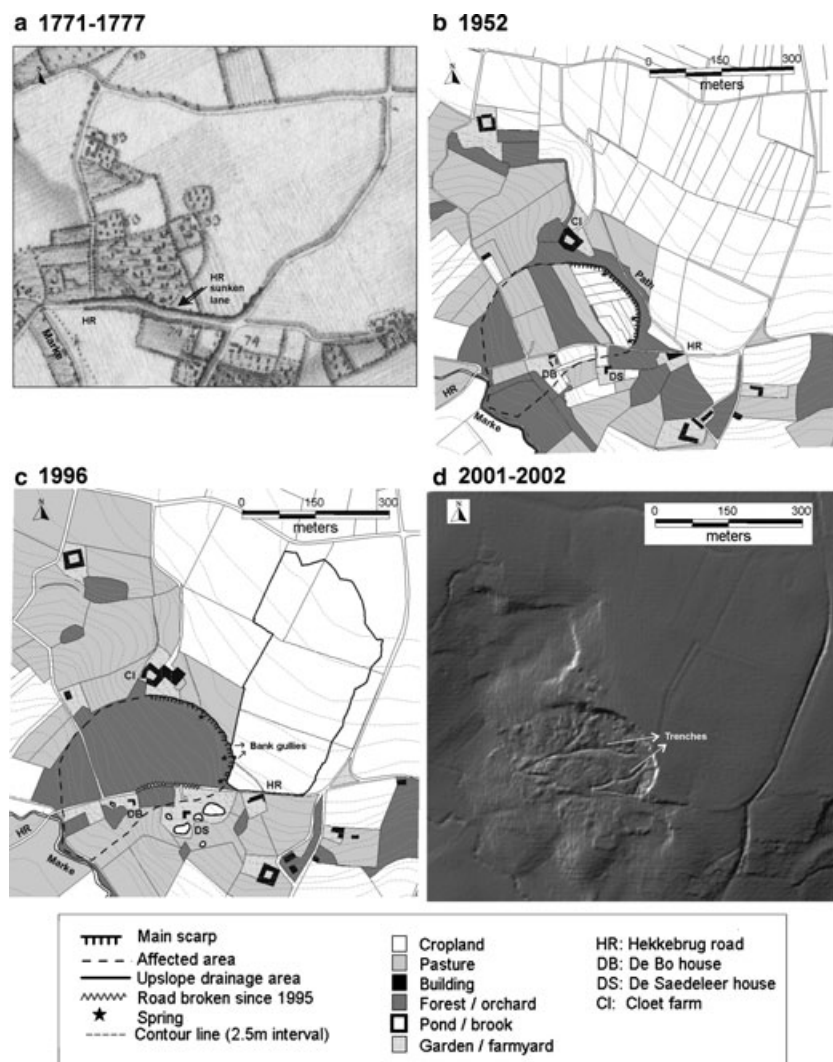
Figure 4 The Hekkebrugstraat landslide site: (a) excerpt of Ferraris map (1771–1777); (b) situation around 1952 based on aerial photograph interpretation; (c) situation around 1996 based on aerial photograph interpretation; (d) topography around 2001–2002 shown on LIDAR-derived hillshade map (DEM of Flanders, 2005).

The map taken from ‘The Atlas of the rural roads’ (1841) only shows roads and field plots. The curved shape of both the plots downslope and the footpath upslope of the present-day main scarp location, suggest the presence of a main scarp which means that the hillslope had already failed by that time. The affected area was at least partly cultivated as the depletion area was divided into small plots.

Undoubtedly, there was a landslide, and the affected area was partly cultivated (Figure 4b). However, cultivation within the depletion area was only possible because of a judicious system of well-maintained ditches draining the water from the springs at the base of the main scarp. Also the pastures in the accumulation area, downslope of the small plots, were drained by small subsurface drainage pipes. In 1955, the agricultural activities in the depletion area stopped, together with the maintenance of the drainage channels, and the entire affected area was planted with poplar trees. The reduced drainage resulted in the build-up of pore water pressures in the debris above the shear plane (Figure 5; Table 2).

After the cessation of agricultural activities in the depletion area in 1955, the trees along the main scarp were cut down. Because the roots were not removed, the root cohesion was conserved for a few years. According to O'Loughlin & Ziemer (1982), Selby (1993), Watson *et al.* (1999) and Sidle *et al.* (2006) half of the root cohesion is lost in 2–10 years after tree removal. It is probably not a coincidence that after several wet months in 1960, about 5 years after tree removal, a small slice fell off the main scarp (Figure 5) near the farm of Cloet (Figure 4b).

Comparison of Figure 4b,c indicates that in the area upslope of the Hekkebrugstraat landslide average plot size increased from 0.8 ha in 1952 to 2.6 ha in 2005. During intense rain storms, this increase in plot size and the growing of maize, which is characterized by higher runoff curve numbers (i.e. 88) than wheat (i.e. 84; Soil Conservation Service, 1972) caused an increase in surface runoff from the upslope drainage area towards the main scarp. This runoff was collected in the depletion area, because of the absence of effective drainage. In 1980, attempts were made to improve this drainage by installing closed 0.40-m diameter drainage pipes along the Hekkebrug road from the southern limit of the

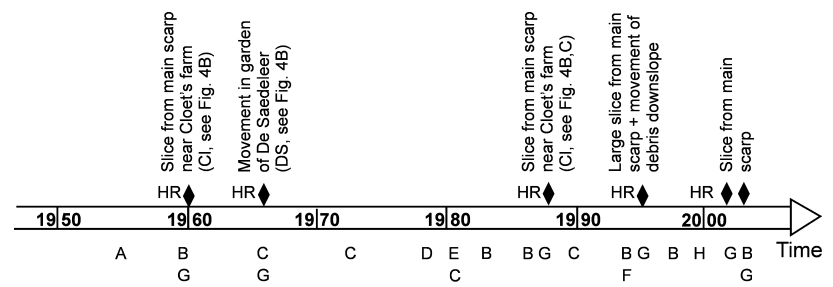
Preliminary causal factors:

- A: End of agricultural activities and maintenance of drainage ditches in depletion area
- B: Road works: filling up and asphaltting of sunken lane (i.e. Hekkebrug road; see Fig. 4A,B)
- C: Decreased drainage due to poor maintenance of drainage ditches in depletion and accumulation area
- D: Increased surface runoff from upslope cropland (see Fig. 4B,C)
- E: Installation of closed drainage pipes along the road in the affected area increased evacuation of surface runoff from upslope cropland to Marke brook, and decreased evacuation of water in affected area
- F: Creation of ponds in De Saedeleer's garden (DS, see Fig. 4B,C) and deposition of 50 truck loads soil material to establish the garden
- G: Period of persistent rain
- H: Removal of toeslope upslope from the De Bo house (DB, see Fig. 4B,C) and relocation of debris back upslope in the depletion area

Triggering causal factors:

HR: Large (i.e. Generally > 100 mm) rainfall in month prior to reactivation

Figure 5 Preliminary and triggering causal factors responsible for reactivations of the Hekkebrugstraat landslide during the last 50 years.

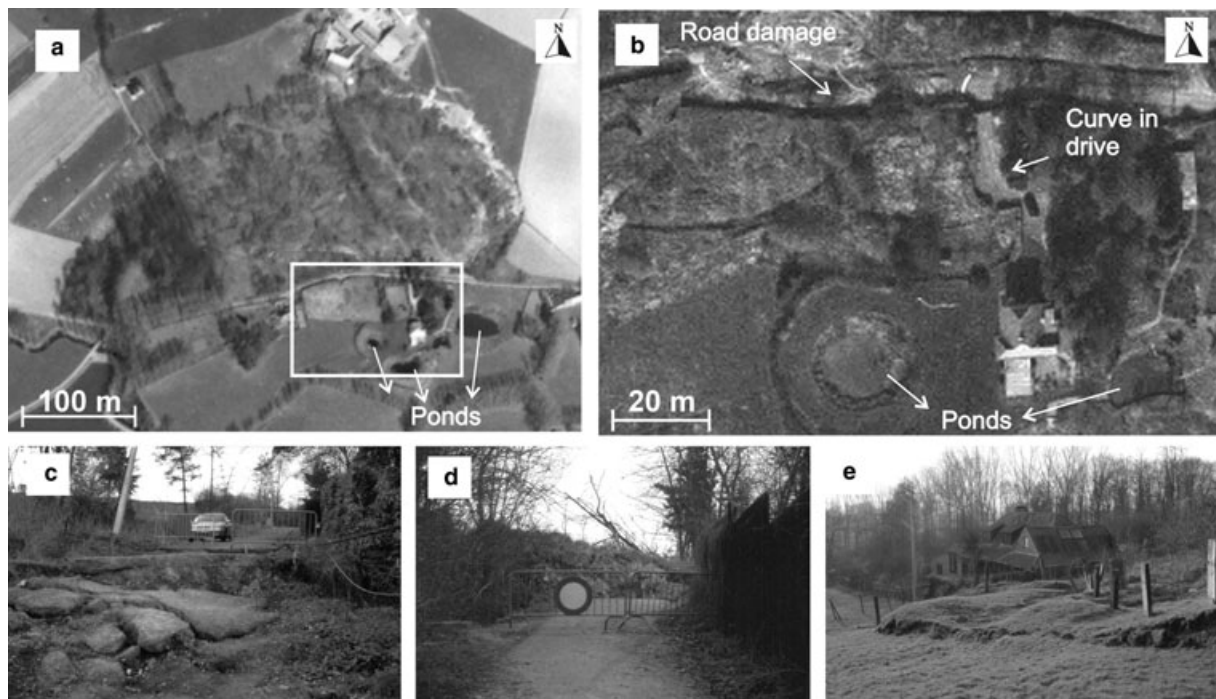
Land-use changes at the site were not limited to changing farming practice and road improvement. In 1993, three large ponds, each having a diameter ranging from 10 to 40 m, were dug in De Saedeleer's hilly garden (Figures 4c and 6a,b). To establish the garden, the excavated soil was deposited on the hillslope together with about 50 truck loads of additional soil. As excavations result in oversteepened slopes, and addition of extra soil material causes overloading (Keaton & Beckwith, 1996; Figure 5; Table 2), the creation of ponds on inherent unstable slopes is not recommended. The water supply system was also inappropriate as it consisted of a series of cascades transporting the water from an upslope spring through the ponds without any provision for draining the water that was leaving the third pond. This water flowed freely into the meadows downslope, creating a wetland.

Figure 6 The Hekkebrugstraat landslide: (a) aerial photograph (NGI, 1996). White rectangle indicates enlarged area of De Saedeleer's garden (DS in Figure 4b,c) shown in (b); (b) detail of orthophoto (OC-GIS Vlaanderen, 1998) showing part of De Saedeleer's garden. In the north the road is damaged by debris. The curve in the drive is caused by the downslope movement of the debris. This movement occurred after April 1996, because the curve is not present on (a); (c) damage to the road and electricity lines (2001). In the back, the 8-m-high main scarp can be distinguished; (d) the downward movement of the debris blocked the road (2001); (e) since 1999, the landslide foot has been located only a few metres from De Bo's house (DB in Figure 4b,c).

In September 1995, the 800 large poplar trees in the accumulation zone were cut and replaced by young poplar trees. As a consequence of the landslide reactivation, two buildings were threatened. Due to the scarp retreat a barn of the Cloet family became located only a few metres upslope from the main scarp, and De Bo's house was threatened by the foot of the approaching landslide (Figures 6e and 4).

In 1996, an attempt to dig a drainage channel in the affected area, from the base of the main scarp to the Marke brook, failed. As no other control measures were taken, movement of the landslide continued, and in 1997 the landslide foot expanded downslope. A mixture of clayey debris, asphalt and stone bricks covered the pasture between the De Saedeleer and the De Bo houses (Figure 6b,e). In the upslope cropland area, the farmer had dug drainage channels

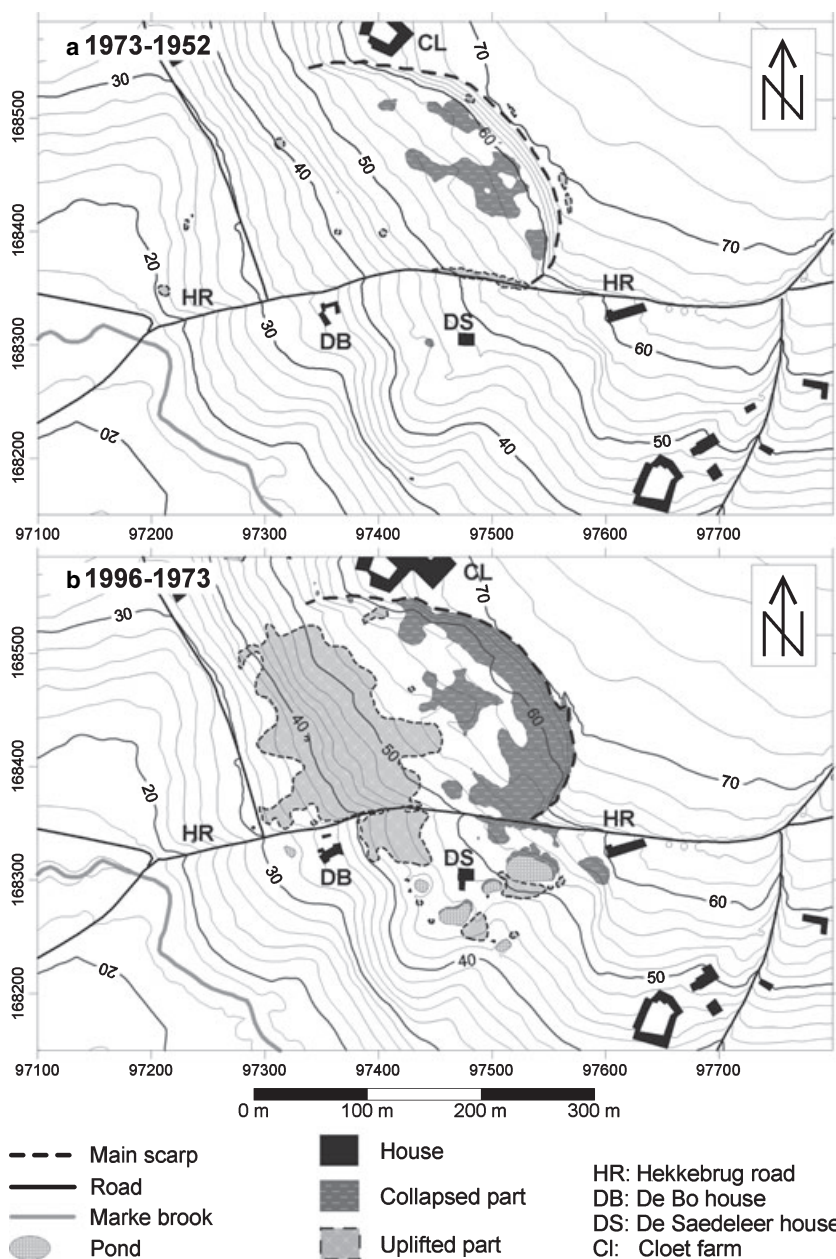
Figure 7 shows the vertical displacements of the Hekkebrugstraat landslide between 1952 and 1973, and

Figure 7 Uplifted and collapsed parts (maxima +4 and –7 m, respectively) within the Hekkebrugstraat landslide obtained by subtraction of detailed DTMs produced from aerial photographs of (a) 1973 and 1952 and (b) 1996 and 1973. The maps are produced with a confidence interval of 68.3% (i.e. 75 cm). Only differences in altitude of 75 cm or more are considered significant (Dewitte, 2006).

between 1973 and 1996 obtained from DTM comparisons by Dewitte (2006). In contrast to limited topographical changes found between 1952 and 1973, major displacements occurred between 1973 and 1996. Immediately downslope of the 1996 main scarp a large collapsed zone with vertical movements of up to -7 m can be distinguished, whereas in the accumulation area debris was uplifted by up to 4 m. The displaced landslide foot threatening De Bo's house (Figure 6e) is also clearly visible. After 1996, this landslide foot moved progressively downslope, until it was located only 3 m from De Bo's house. This analysis of Figure 7 corresponds well with the historical records presented above, showing that the reactivations of 1960 and 1966 affected only limited areas, whereas the reactivation starting in February 1995 affected almost the complete landslide. Some of the vertical displacements shown in Figure 7b correspond well with locations of human interventions discussed earlier. Examples are the uplifted parts along the Hekkebrug road north of De Saedeleer's house (DS; between 34 and 54 m a.s.l.) resulting from successive road improvement (Figure 5), and the vertical soil surface displacements around the ponds dug near De Saedeleer's house.
