Advancing Culture of Living with Landslides

Volume 4 Diversity of Landslide Forms

Flash Floods in the Rwenzori Mountains— Focus on the May 2013 Multi-Hazard Kilembe Event

Abstract

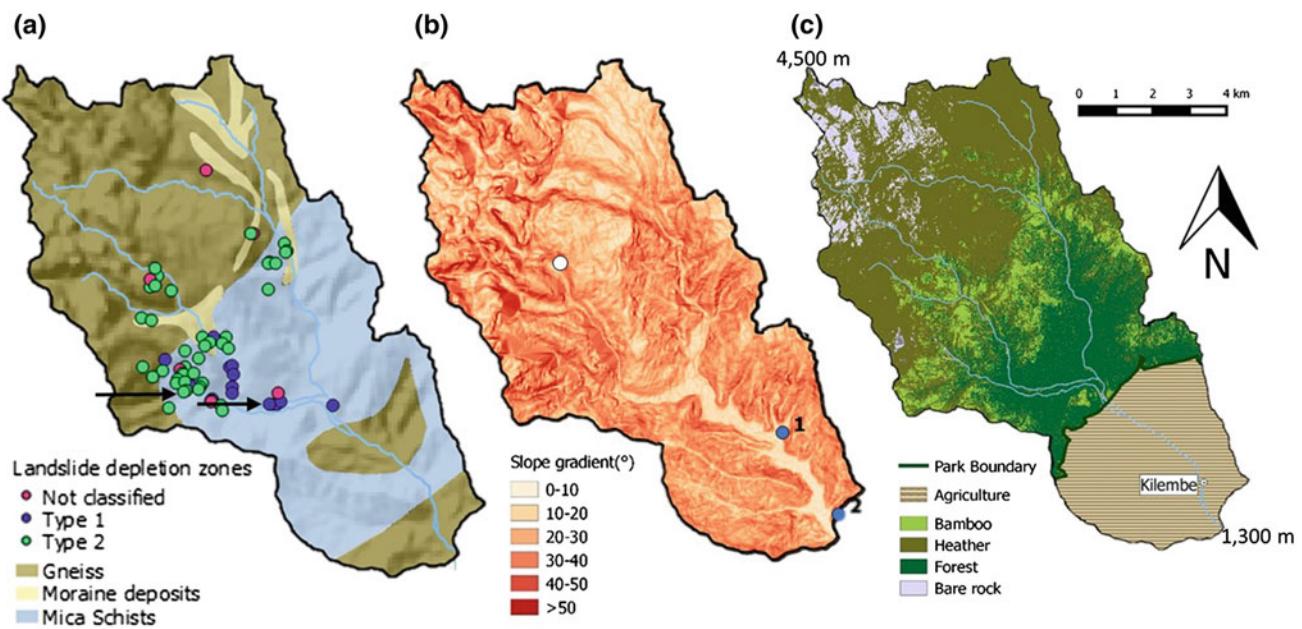
Fig. 2 Biophysical properties of the Nyamwamba catchment. **a** catchment lithology (Source GTK Consortium 2012); location of all identified landslides are indicated by dots **b** catchment slopes derived from SRTM 1" at 30-m resolution (USGS 2014); white dot represents Kalalama camp rainfall station, blue dots represent cross sections

selected for discharge estimation, **c** land cover map derived from supervised classification of the SPOT 6 image shown in Fig. 4. Black arrows show the location of the illustrated landslides in Fig. 5a, b (Jacobs et al. 2016c)

On May 1st 2013, 180.6 mm of rainfall was measured at Kalalama camp (Fig. 2b) and 98.3 mm in Kilembe. The days preceding the event were characterized by moderate to low rainfall amounts. Based on the high-resolution regional climate model results by Thiery et al. (2015), the 24 h precipitation limit of 180.6 mm was exceeded four times at Kalalama camp between 1999 and 2008 and its estimated return period is 2.9 years. From reports on this flash flood (LIDEFO 2013; Reliefweb 2013), the 98 mm rainfall observed on May 1st in Kilembe town was concentrated in ca. 6–8 h. The return periods for this rainfall observed over 6–8 h was calculated and found to range from 6.6 to 5.3 years respectively.

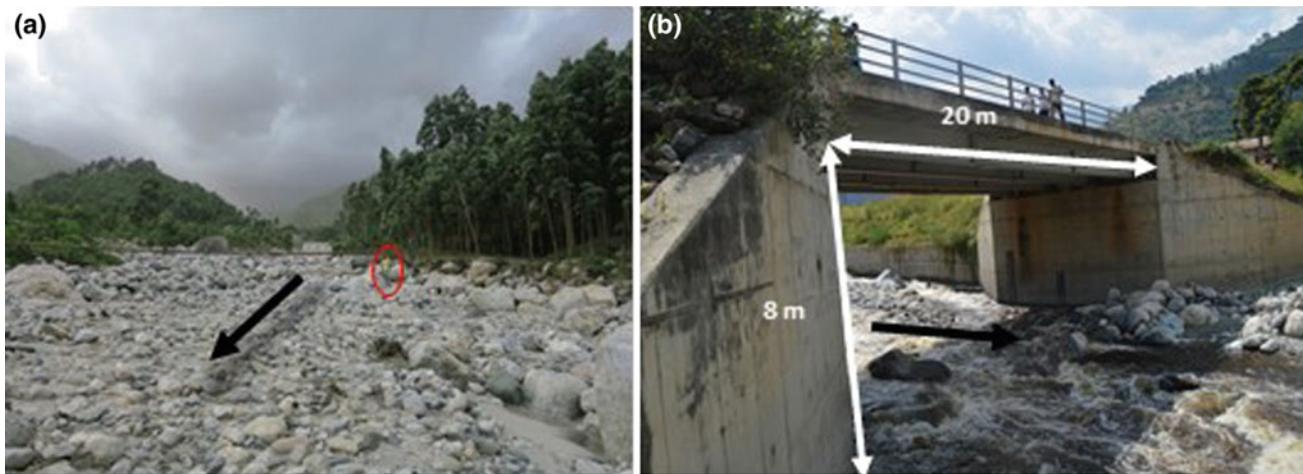
Fig. 3 River cross-sections selected for peak flow discharge estimations

made and the roughness of the river bed was described in the field (Fig. 3a). As a second cross section, a bridge was selected downstream of the first cross section (Fig. 3b) where the water reached the level of the tarmac road. Here the local slope was estimated using a 1:50,000 topographic map (Department of Lands and Survey Uganda 1972). The bridge itself is not supported by piers and during peak discharge the water level reached the tarmac of the bridge (Fig. 3b).

For the reconstruction of the peak flow discharges of the Nyamwamba river, Manning's equation Eq. (1) was applied to two river cross sections (Figs. 2b and 3).

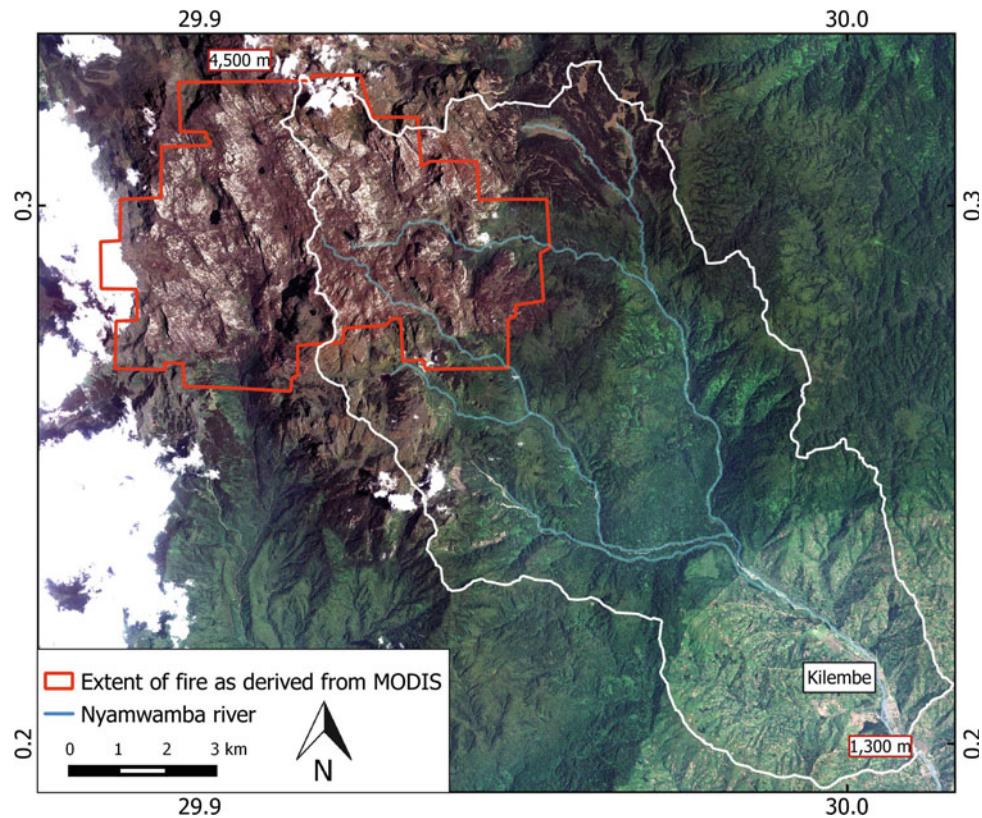
A fire was detected on MODIS images between the 9th and 11th of February 2012 and covered an area of 42 km² (Fig. 4). The delineated fire corresponds well to the occurrence of bare rock visible on the SPOT6 image taken in January 2013, i.e. almost one year after the fire (Fig. 4). This bare rock was also observed in the field in September 2014. A total burned area of 19 km² was located within the Nyamwamba catchment, accounting for 18% of its surface area at the second cross section. A total cumulative rainfall of <0.2 mm was measured in the four weeks preceding the fire (Jacobs et al. 2016c).

Fig. 4 Extent of the fire overlain on the SPOT6 pan-sharpened image acquired in January 2013

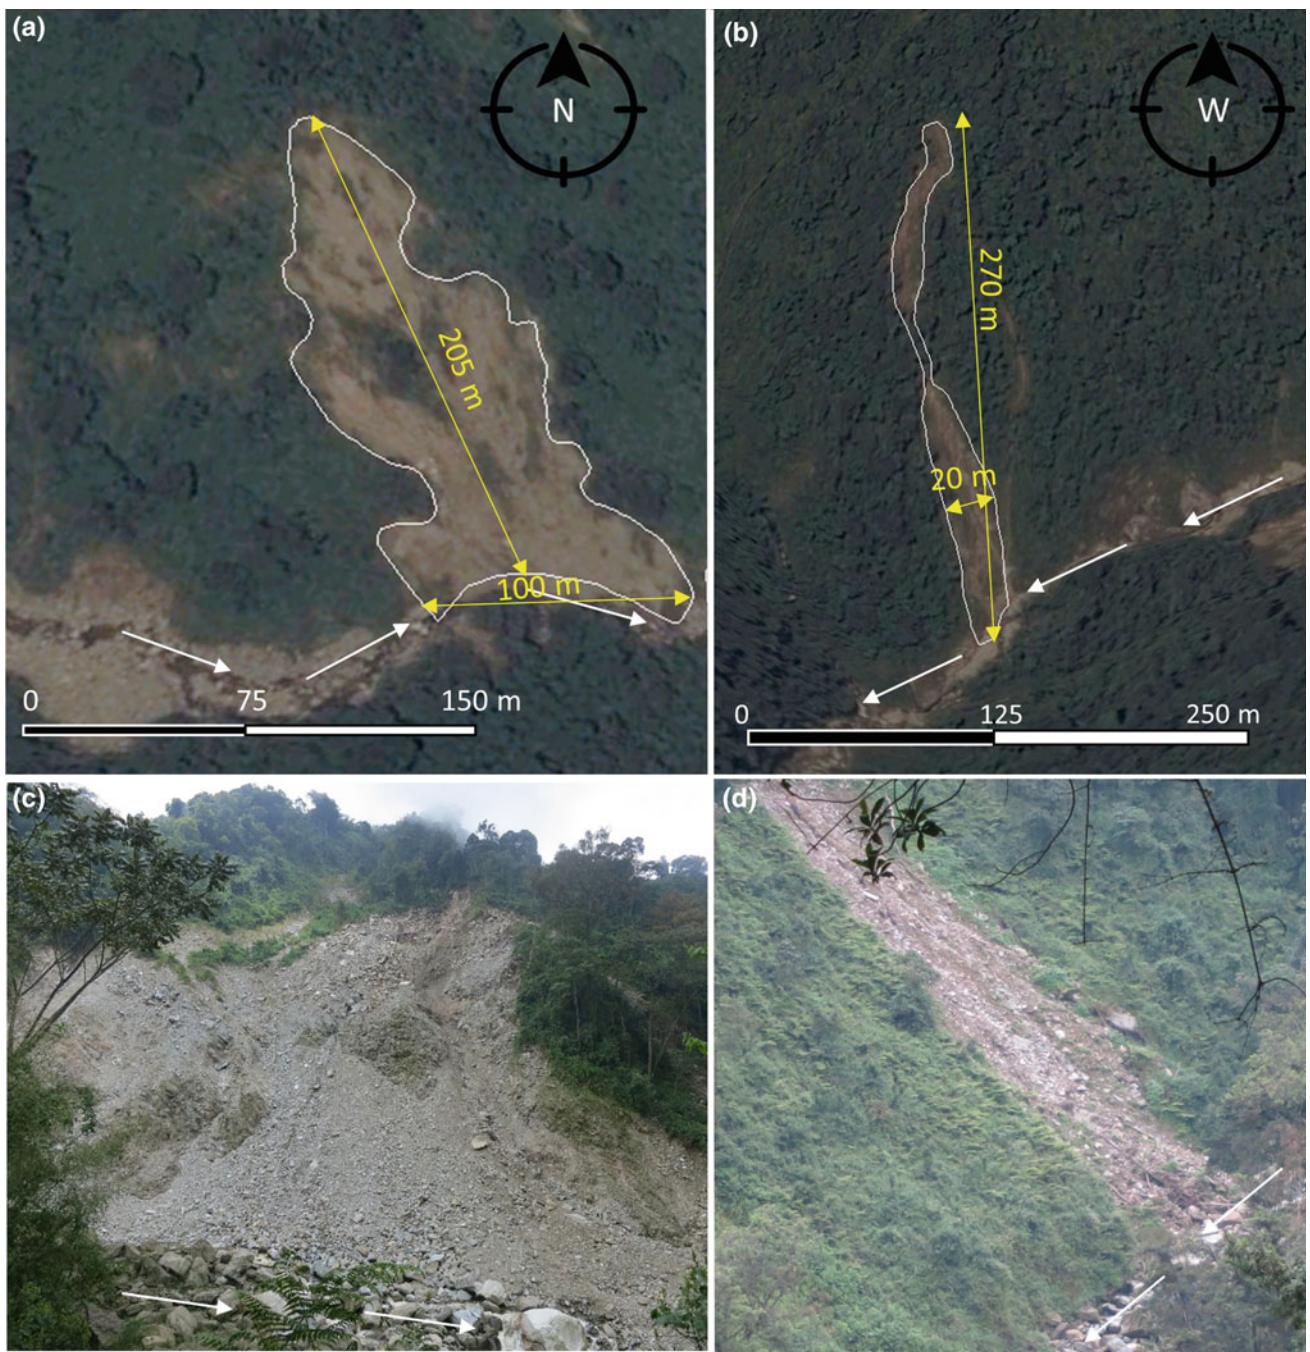
Two categories of landslides are distinguished: (1) landslides adjacent to the river with lengths typically equal or smaller than twice the maximal width, hereafter referred to as Type 1 (Fig. 5) and (2) debris flows or slides with typically a narrow run-out zone, not necessarily connected to the river system (length typically larger than three times the maximal width, Type 2; Fig. 5). Based on field observations of deep scour

and the typically wide base of the Type 1 landslides, they are interpreted to have been triggered by scour and bank failure at the slide foot. Type 2 landslides are triggered directly by rainfall. This distinction is relevant because of their different triggering mechanism and their different role in the hazard interactions. Generally we consider that Type 2 landslides are triggered at their top, while the Type 1 landslides are triggered close to their base.

Fig. 5 Illustration of the two landslide types. **a, c** landslides adjacent to the river with large width-to-length ratios. **b, d** debris flows with a narrow run-out zone. *Top* landslides observed with GE images and

bottom examples observed in the field do not depict the same landslides, but serve as illustration

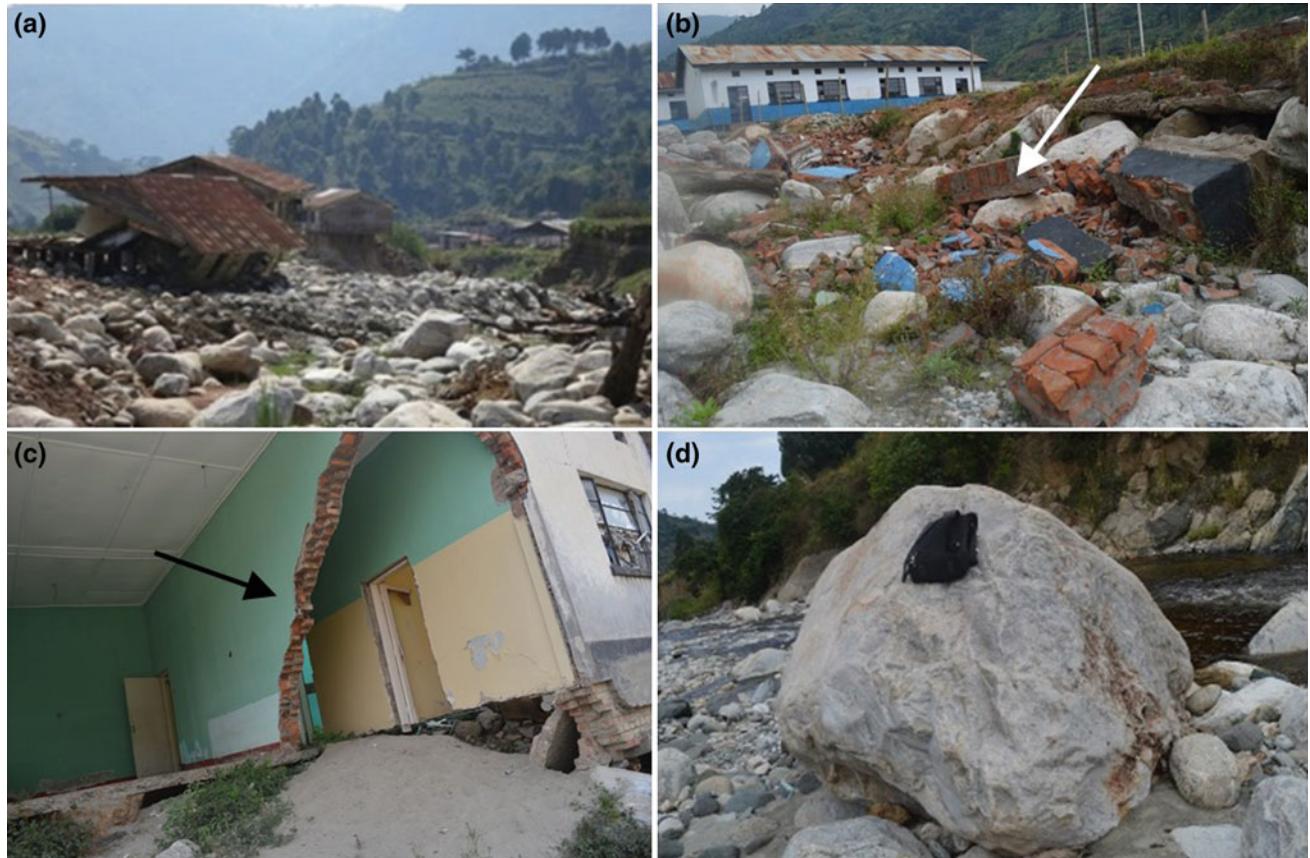
The damage inventories are given in Table 2. The buildings destroyed or damaged show both signs of water damage as well as damage through the impact of large boulders (Fig. 6a–c). These transported boulders have a diameter

**Fig. 6** Examples of damage caused by the flood. **a** River bed and scour, **b** destruction of house foundation (white arrow), **c** destruction of house due to impact from debris (black arrow), **d** illustration of boulder size frequently found in the valley (backpack for scale)

exceeding 1.5 m (Fig. 6d). The foundation of the buildings nearest to the river bed were often completely destroyed (Fig. 6b). Furthermore, the damage to infrastructure and specifically buildings, tarmac roads and bridges can only be explained by the large volume of debris transported by this high-energy torrent. The increase in area covered by debris in the Nyamwamba valley up to Kasese town is 34.4%.

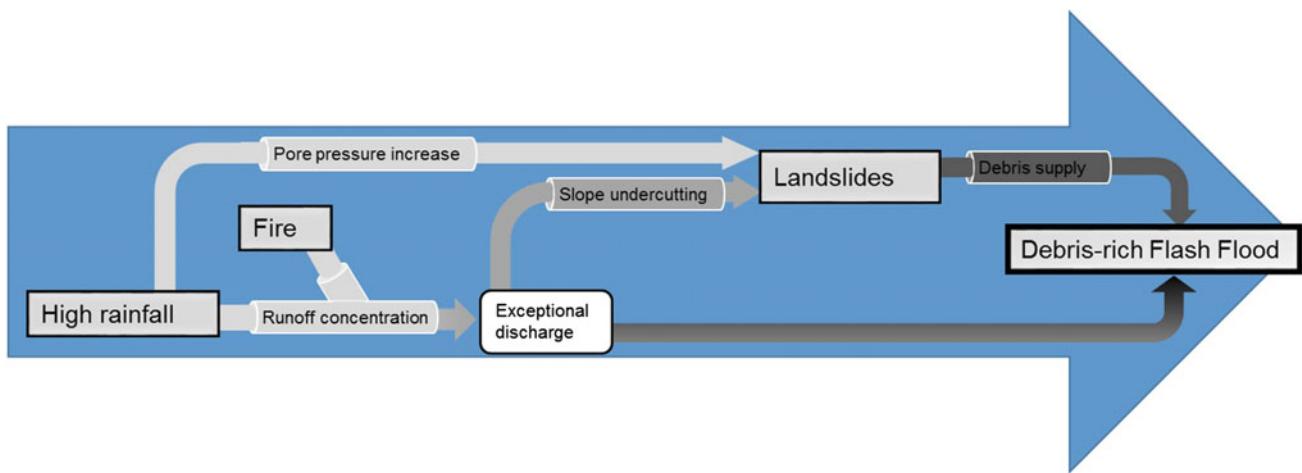
Fig. 7 Hazards (black squares), cascade effects, interactions and processes at play during the Kilembe flood on May 1st 2013 (Jacobs et al. 2016c)

The landslides (re)activated on May 1st 2013 also aggravated the nature of the flood by supplying debris to the river flow. Some of the landslides are furthermore indirectly triggered by the fire. Although none of the landslides occurred in the burned area, more than half of the debris-supplying landslides are triggered at least partially by an increased river flow which for this flood event, as stated above, can mainly be explained due to the fire. This illustrates the importance of distinguishing between the two types of landslides. All these interactions need to be taken into account to fully understand the potential hazard interactions and cascades.
