Article

Characteristics and Distribution of Landslides in the Populated Hillslopes of Bujumbura, Burundi

Keywords: landslide inventory; controlling and triggering factors; river incision; gully erosion; historical aerial photographs; Africa

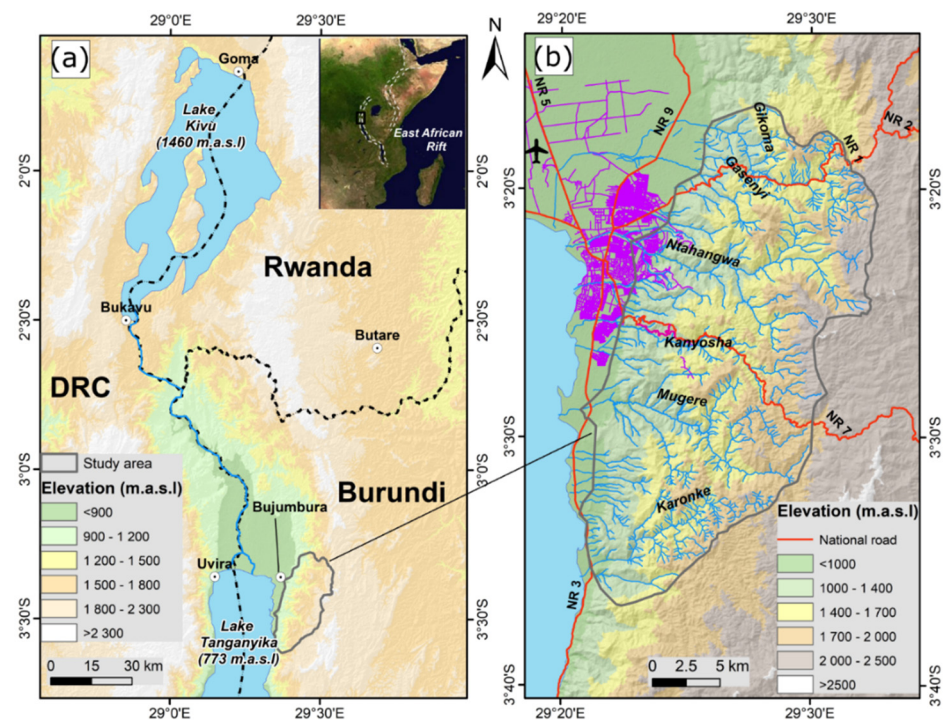
Figure 1. Location of the study area. (a) Central portion of the western branch of the East African Rift; (b) populated hillslopes of the city of Bujumbura with the drainage network of the main watersheds (delineated with the grey line). The hillshade is derived from 1 Arc-Second SRTM data [47]. The road network in violet and the national roads (NR) in red are from OpenStreetMap.

The NTK Rift, in which Bujumbura is located, is situated in the central section of the western branch of the East African Rift (Figure 1a). In this region, tectonic uplift, accompanied with seismic activity and faulting, has initiated landscape rejuvenation through knickpoint retreat, enforcing topographic steepening [16,36–38]. This tectonic setting, combined with a tropical climate that favors the occurrence of intense rainfall events and deep weathering, makes the region a landslide hotspot in Africa [6,16]. It is characterized by a large diversity of landslides of various sizes (up to tens of km²) and ages [17,33,35,38,39]; some being much older than 10,000 years [16]. Most of the recent, often shallow landslides (i.e., being <5 m deep) that occurred over the last decades were triggered by rainfall; and a general link between rainfall seasonality and their occurrence has been recently demonstrated [16,33]. During that same period, none of the observed landslides in the region were triggered by earthquakes [16]. While we cannot exclude that earthquakes can trigger landslides (or play a role in their occurrence), their return period can be long and their impacts as triggering factors can be unnoticed over such a short window of observation [16,37]. Moreover, deep-seated landslides in the region can occur without any apparent trigger, due to the long-term evolution of preconditioning drivers alone, such as rock weathering and regolith formation [40]. This observation has an implication for our interpretation of the many landslides that occur in isolation.

The city of Bujumbura is bounded by Lake Tanganyika in the west, and one of the hilly NTK rift shoulders in the east (Figure 1a,b). It is one of the major cities of the region, currently counting about one million inhabitants. The city is also experiencing a rapid and sustained urban expansion that is typically uncontrolled [4]. Due to the presence of Lake Tanganyika, this expansion is also taking place east of the city center, i.e., on the hilly surroundings of the city. The population of Bujumbura is overall highly exposed to hazards such as landslides because of poorly designed urban infrastructures and road networks that often do not consider constraints from the local environmental context. Also, local vulnerability is high and the resilience towards landslide impacts is low because of poverty [41]. Finding safer location alternatives is often impossible for a large share of the population because of limited financial resources. This is particularly true for the population living in the hilly surroundings of Bujumbura, who have generally lower standards of living and rely on small farming activities and small-scale building works.

Analyzing the landscape, we see that the hillslopes east of the city are typically incised by rivers flowing westward towards the city center (Figure 1b). The lower reaches of the rivers are in the rejuvenated landscape and affected by several knickpoints. Upslope, the rivers evolve in the relict landscape, where catchment slopes are less steep (Figure 2a). The lithology is made of Precambrian metamorphic (gneiss, quartzites, and meta-quartzites) and igneous rocks (granites), as well as Pleistocene rift sediments (Figure 2b). Gneiss and rift sediments dominate the western part of the study area, while granites prevail in the east. Meta-quartzite and quartzite are dispersed and often used for the extraction of building materials; pegmatite bands are intercalated within gneiss and quartzite units. Rift sediments are thick, while gneiss and granites are usually highly weathered. The region is crossed by active faults related to the rifting dynamics [36,37]. Typically of the NTK Rift, the climate of Bujumbura is tropical, with an average annual rainfall of 1400 mm (the southern catchment of Bujumbura [45], with most of the precipitation occurring during the October–May rainy season [46].

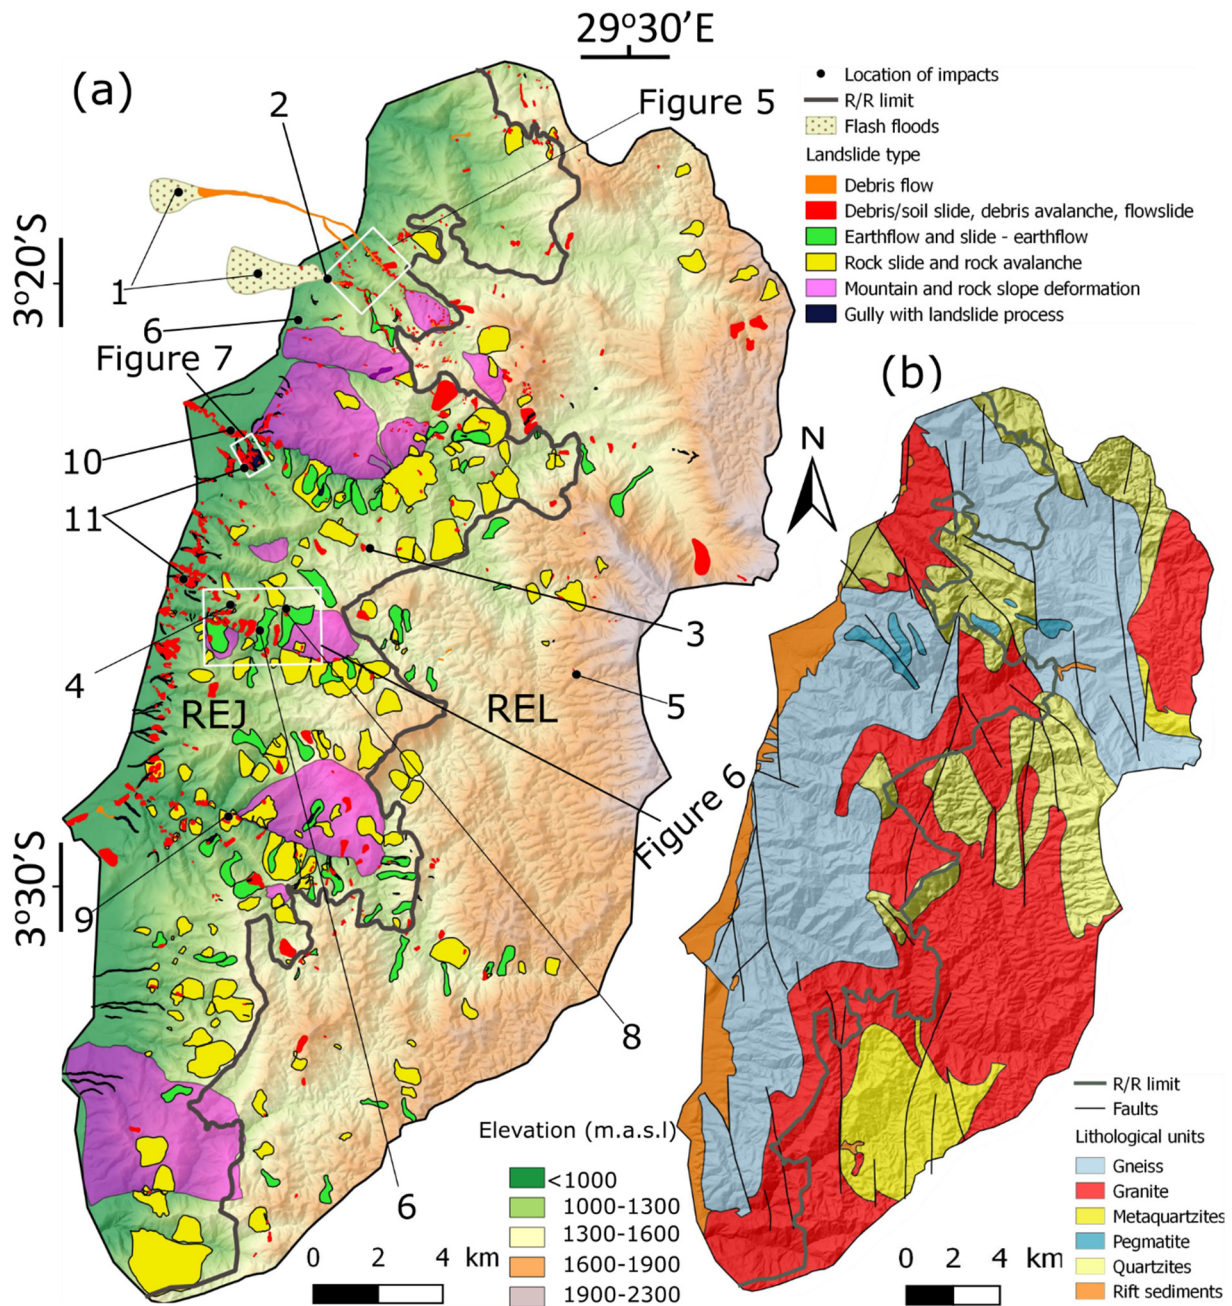
Figure 2. (a) Map of the location of the landslides inventoried in the area by type. The “R/R limit” line shows the position of the contact between the rejuvenated (west) and the relict (east) landscapes (REJ and REL)—note the difference in landslide density. The numbers represent the location of recent landslide events whose impacts have been assessed (see Table 3 for further details). (b) Lithological units and active faults for the study area (after [54]). White rectangles represent the locations of Figures 5–7.

We inventoried 1286 landslides of various types (Figures 2–4). All mapped landslides were grouped into six categories with similar characteristics according to the mechanisms of slope failure and the materials involved (Figure 2a and Table 2). Differentiation between slides, flowslides, and avalanches was not always possible for older landslides, whose fresh morphologies could not always be accurately observed. The differentiation between mudflows and debris flows was also sometimes complex, and we have therefore considered them all as debris flows.

Gullies are mainly observed in the rejuvenated landscape (Figure 2). Gullies developing within landslides are, in general, associated with active earthflows. However, the majority of the gullies are not a consequence of a landslide process. Such gullies are found in the lower part of the study area at the outskirts of the city of Bujumbura within the unconsolidated Rift sediments (Figures 2 and 7). Out of the 93 gullies mapped in this region, 55 were initiated after the 1950s. There are 79 active gullies that show clear signs of extension with an average headcut retreat of around 100 m over the last 70 years, the largest retreat being >250 m. Landslides are frequent along the banks of these gullies. In some case, gully erosion triggers relatively large slope failures (Figure 7).

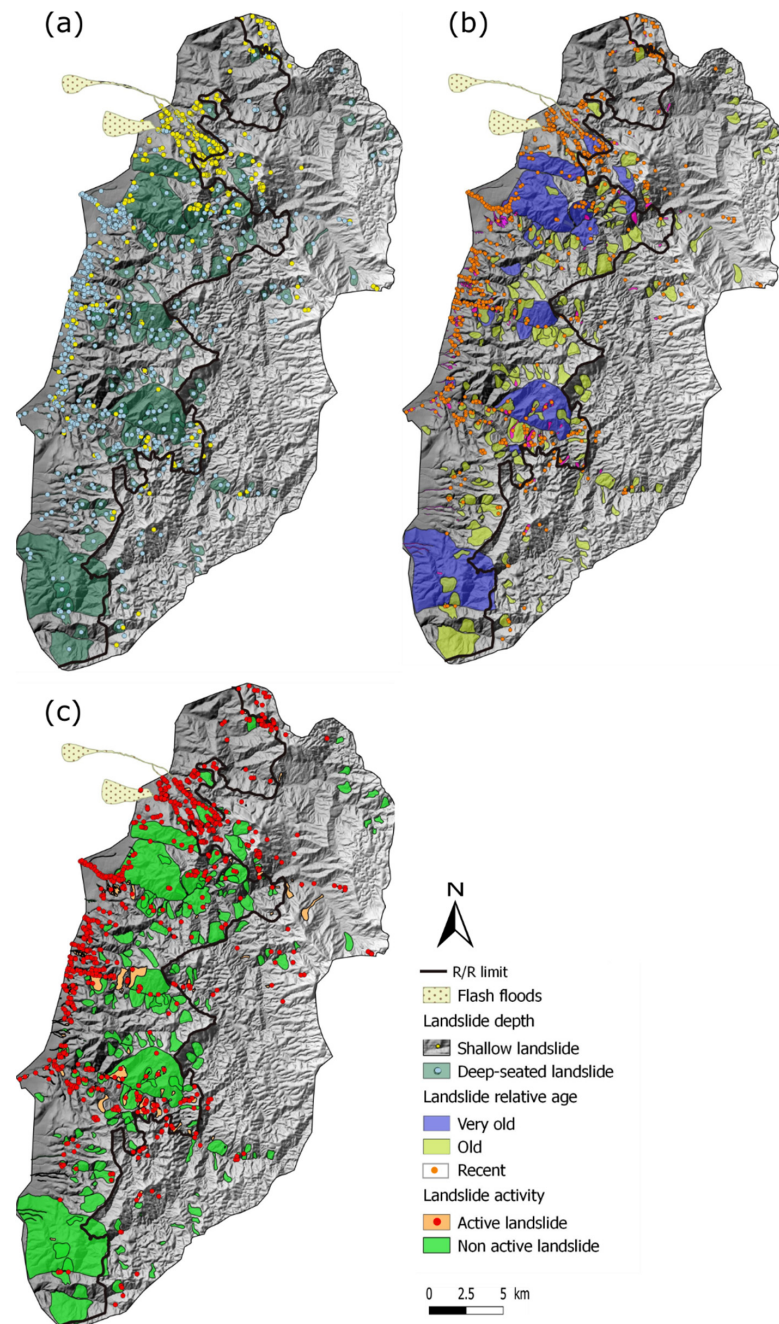
Figure 3. Mapped landslides classified by (a) depth, (b) relative age, and (c) level of activity. The hillshade is from the 10-m resolution DEM (Table 1). The landslides $<14,000\text{ m}^2$ are represented with a dot so that they are visible at the scale of the maps.

Many of the shallow landslides inventoried are relatively small debris slides and debris avalanches (Figures 2a, 3a and 4a,b). The signatures of shallow landslide scars tend to disappear quickly from the landscape, sometimes already after a few months. Hence, all mapped shallow landslides have been detected in recent high-resolution satellite images and/or in the field; their identification on the historical aerial photographs being difficult because of their lower quality [48]. The smallest landslides observed in the field were not visible on the satellite images either, especially when they occurred alongside road cuts or river banks.

We saw clusters of shallow landslides occurring after heavy rainfall events (clusters of yellow dots in Figure 3a). There, cascading processes where debris slides and avalanches are connected to debris flows were observed. One clear example of such a cluster—and of the related cascading events—occurred on 9 February 2014, and impacted the national road NR1 [33,40]. An accurate field-based inventory carried out a few weeks after the event and further complemented by satellite image analysis allowed us to map 307 recent shallow landslides (Figure 5). Most failures were debris slides and avalanches, many being connected to debris flows and the river network. The material brought by these landslides

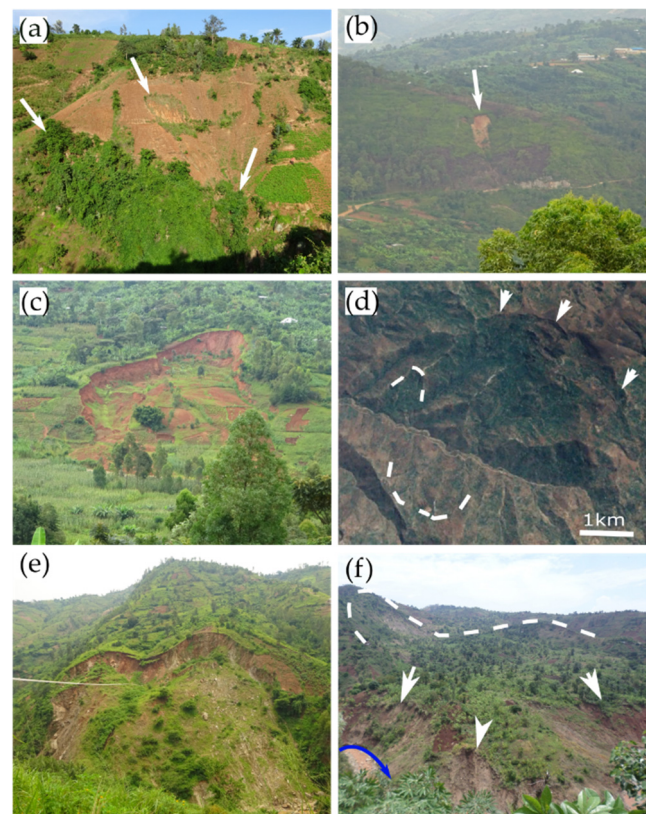
Figure 4. Examples of landslides of the inventory. (a) Cluster of rainfall-triggered shallow debris slides and avalanches in agricultural crops (headscarps located with white arrows). Photo taken in January 2019 (-3.382° , 29.369°). (b) Shallow planar slide above a road. Photo taken in January 2019 (-3.355° , 29.492°). (c) Recent rotational slide in regolith overlying gneiss in the relict landscape. Photo taken in January 2019 (-3.381° , 29.494°). (d) Old and very old landslides in the Mugere catchment area (©Google Earth, image from December 2018). White arrows locate the head of a mountain slope deformation (-3.477° , 29.419°) while dashed lines delineate the head of two deep-seated landslides. (e) Recent slide reactivation that occurred in 2012 in the rift sediments of the Ntakangwa catchment. Photo taken in January 2019 (-3.380° , 29.404°). The slide is visible on the historical photograph from the 1950s. (f) Active slide—earthflow developed on gneiss with several recent shallow secondary landslides (white arrows) at its toe (that is eroded by the Kanyosha river). Photo taken in August 2016 (-3.432° , 29.388°).

Deep-seated landslides show a large range of sizes (between 106 m² and 18.4 km²) and are present in all age categories (Figure 4c–f). The majority of these landslides are old or very old, and all mountain and rock slope deformations belong to the latter category. We observed 82 reactivations of old landslides (Figure 4e) that were classified as recent and active processes. These reactivations concern 76 slides and six earthflows. Although only 0.03% of the active landslides are earthflows, they constitute more than 34% of the active landslide areas. Since all the earthflows were already present in the 1950s and 44% of them are active, it shows that they can easily remain active over a timespan of several decades. Field observation and interviews allowed us to infer ground deformation of around 1 m/year. Other earthflows, such as that of Figure 4f, show deformation patterns that attest to more active movements. In that case, we could certainly assume that some parts of the landslide have displacements of several meters per year. The large majority of the earthflows are connected to rivers; therefore, contributing actively to supply sediments to river systems (e.g., Figure 4f, Figure 5e,f, and Figure 6b). The river reaches located downslope of the earthflows are indeed usually debris-rich (e.g., Figure 5).

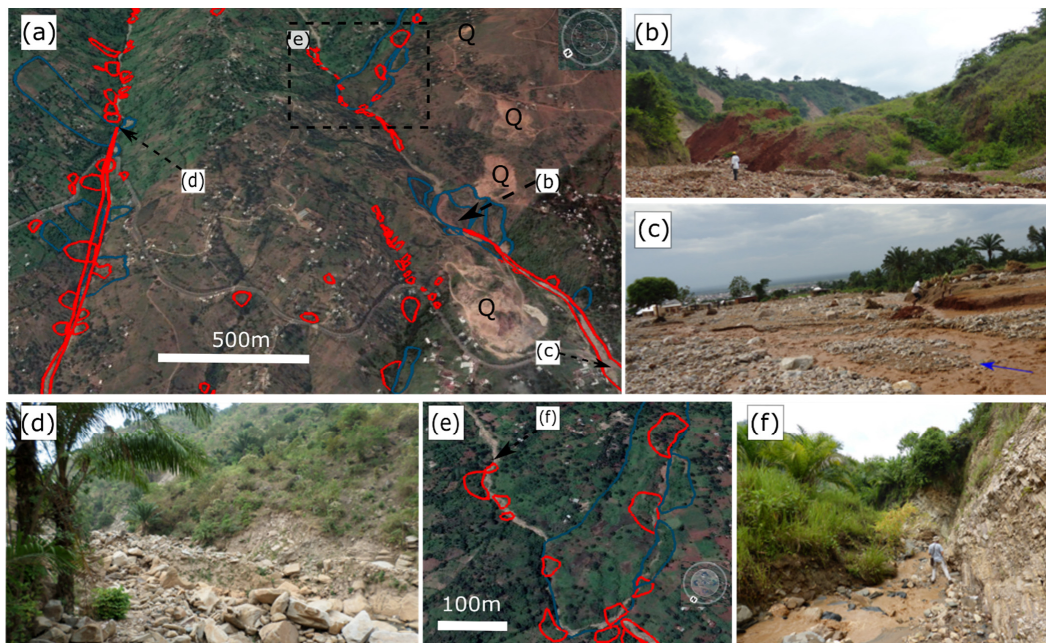
Figure 5. (a) ©Google Earth image (12 March 2021) of landslides triggered by an intense rainfall event in February 2014. Shallow and deep-seated landslides are in red and blue respectively. Note also the presence of quarries and mines (Q). (b) Toe of a landslide dam partly associated with quarrying and mining activities that blocked the river. Photo taken in July 2014. (c) Example of debris-rich flash flood impact in the Gasenyi River, resulting from the breaching of the upstream landslide dam. The photo was taken a few hours after the event at around 1.5 km downstream of the point indicated by the C arrow. (d) Debris flows with lateral sediment supply from debris avalanches. Photo taken in July 2014. (e) ©Google Earth image (7 March 2018) of an active earthflow in contact with the Gasenyi river. (f) Toe of the earthflow and sediment supply into the river system. Photo taken in July 2014.

contributed to debris-rich and kilometer-long flash floods that were associated with this intense rainfall event. Note that a few deep-seated landslides also occurred at that time [40]. One landslide, partly associated with quarrying/mining activities and the mobilization of tailings, was large enough to create a temporary dam on the Gasenyi River that breached and exacerbated the flash floods, leading to dramatic impacts in the city of Bujumbura (Figure 5c and Table 3).

as at the level of road gutters and other runoff concentration zones associated with the impervious surfaces. Landslides are also observed along river banks (frequently of the slide type) and at quarrying/mining sites (Figure 5). Over the last decades, the quarrying of river bed material has increased (in parallel with the growth of the city). As a consequence, the sediment patterns of the rivers are heavily disturbed and so the river flows. A wave of increased river incision is observed in many places. This leads to a local erosion and oversteepening of the river banks, which can cause landsliding, especially in the Rift sediments.

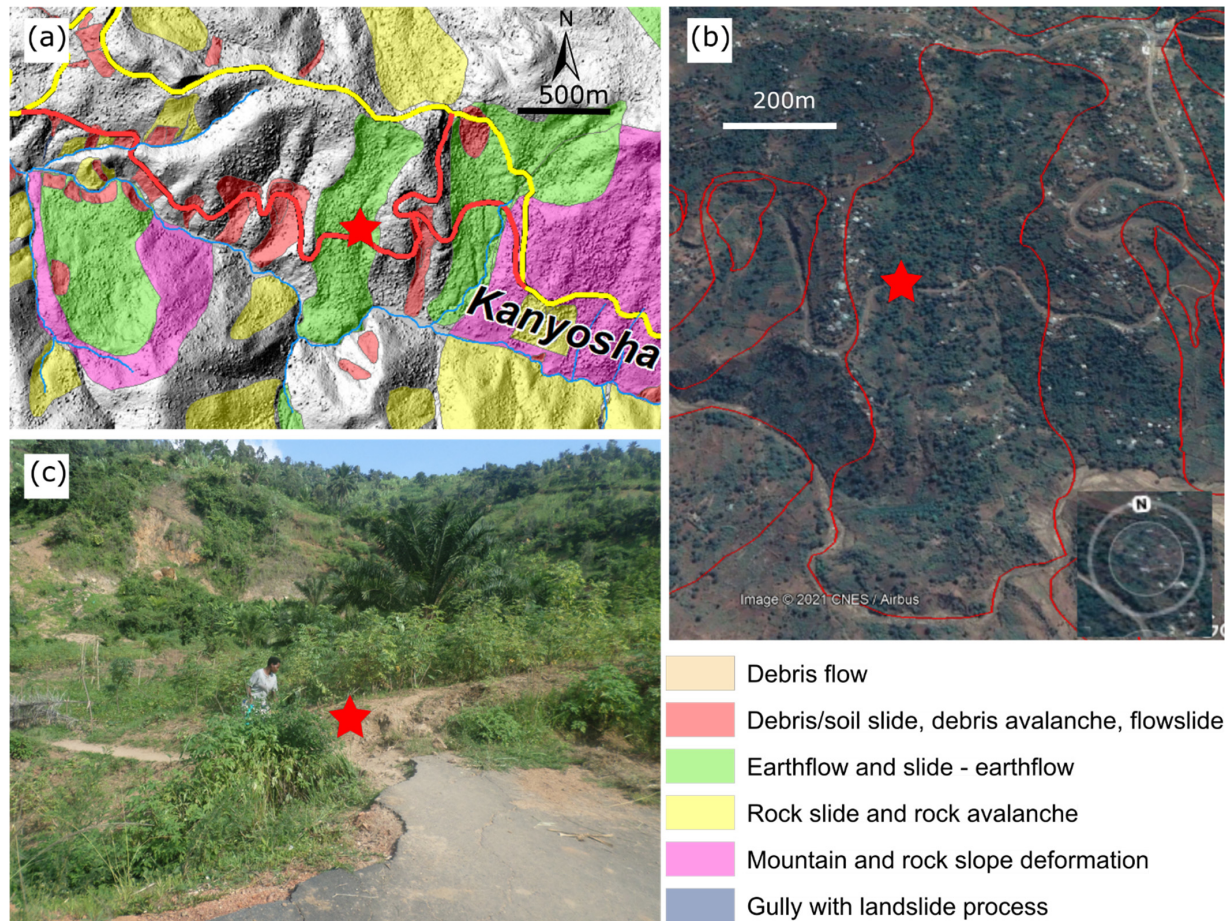
Figure 6. Focus on a landslide impact zone on the national road NR7. (a) Location of the NR7 in the Kanyosha watershed with the distribution of the inventoried landslides. The current road is in yellow, the former section is in red. The hillshade is derived from 1-m-resolution DEM built from Pléiades tri-stereo images (Table 1). (b) Zoom image of one of the active earthflows (©Google Earth image of 05 August 2018). (c) Damaged section of the former road NR7. Photo taken in June 2016 (-3.431° , 29.393°).

Table 3 provides example of impacts from landslides on infrastructure and people. The landslide and flash flood event of 9 February 2014 (see Section 4.1 for the description of the processes; Figure 5) was one of the most destructive events in the region during the last decade. Another example of the destructive impact of landslides was observed on the national road NR 7 (Figure 6). The original road, built between 1980 and 1984, ran parallel with the northern side of the Kanyosha river. However, this design ignored

the presence of numerous landslides, notably the presence of two active large earthflows. Due to the constant damage inflicted to the road, the authorities had no option but to abandon a section with a length of roughly three kilometers. Overall, the large earthflows in the region are frequently associated with pervasive damages, which explains why they are usually less inhabited compared to their surroundings. Pervasive damages are also observed along the gully systems in the Rift sediments (Figure 7) and along some river reaches. The impacts that we have described (Table 3) are clearly an underestimation of the problems that the region is facing.

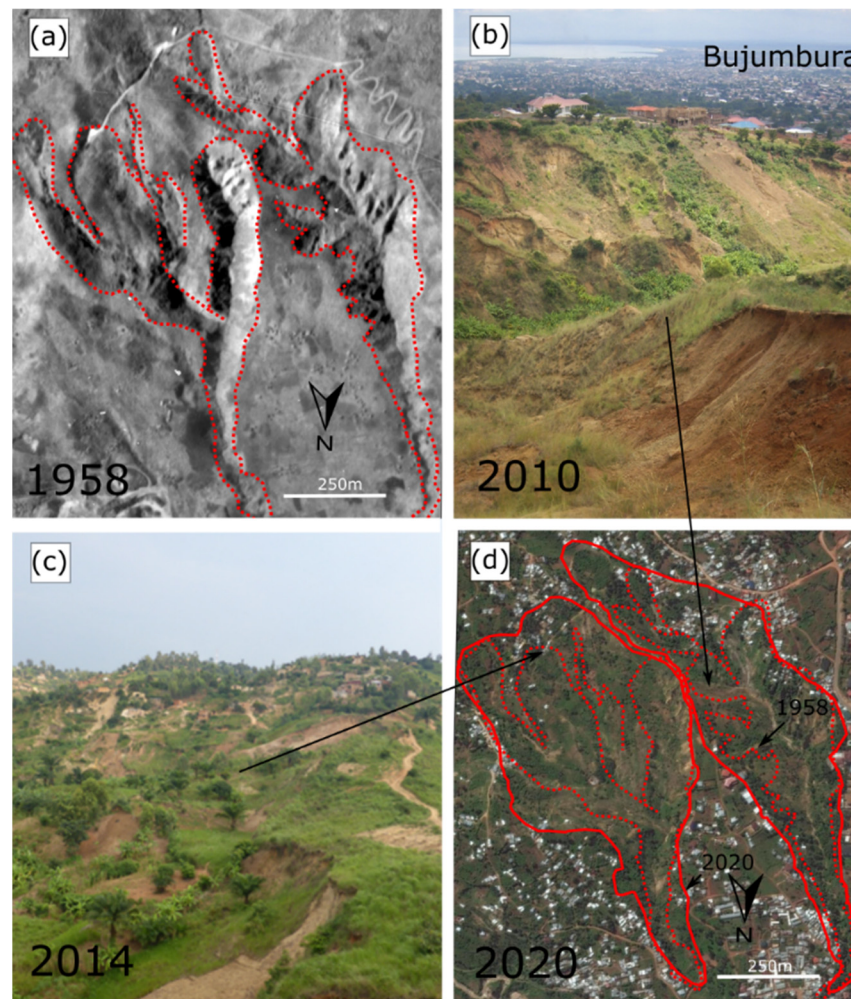
Figure 7. Example of two gullies with landslide processes, located within a densely populated outskirts of Bujumbura (-3.384° , 29.395°). The image sequence illustrates the rapid evolution of the gullies and the built-up area between 1958 to 2020. (a) Historical orthomosaic from 1958; (b) recent photo of the gully at the right (©Alexis Ciza); (c) recent photo of the large landslide that develop in the gully at the left; (d) ©Google Earth image from 28 January 2020. The dotted lines represent the limits of the gullies in 1958.

Since the 1950s, both the built-up area and the road network have been largely extended, particularly over the outskirts of the city (Figure 7). The landslides that are directly connected to the road network are typically small debris slides/avalanches/flows and rockfalls, usually observed after a rainstorm. They are observed along road cuts as well

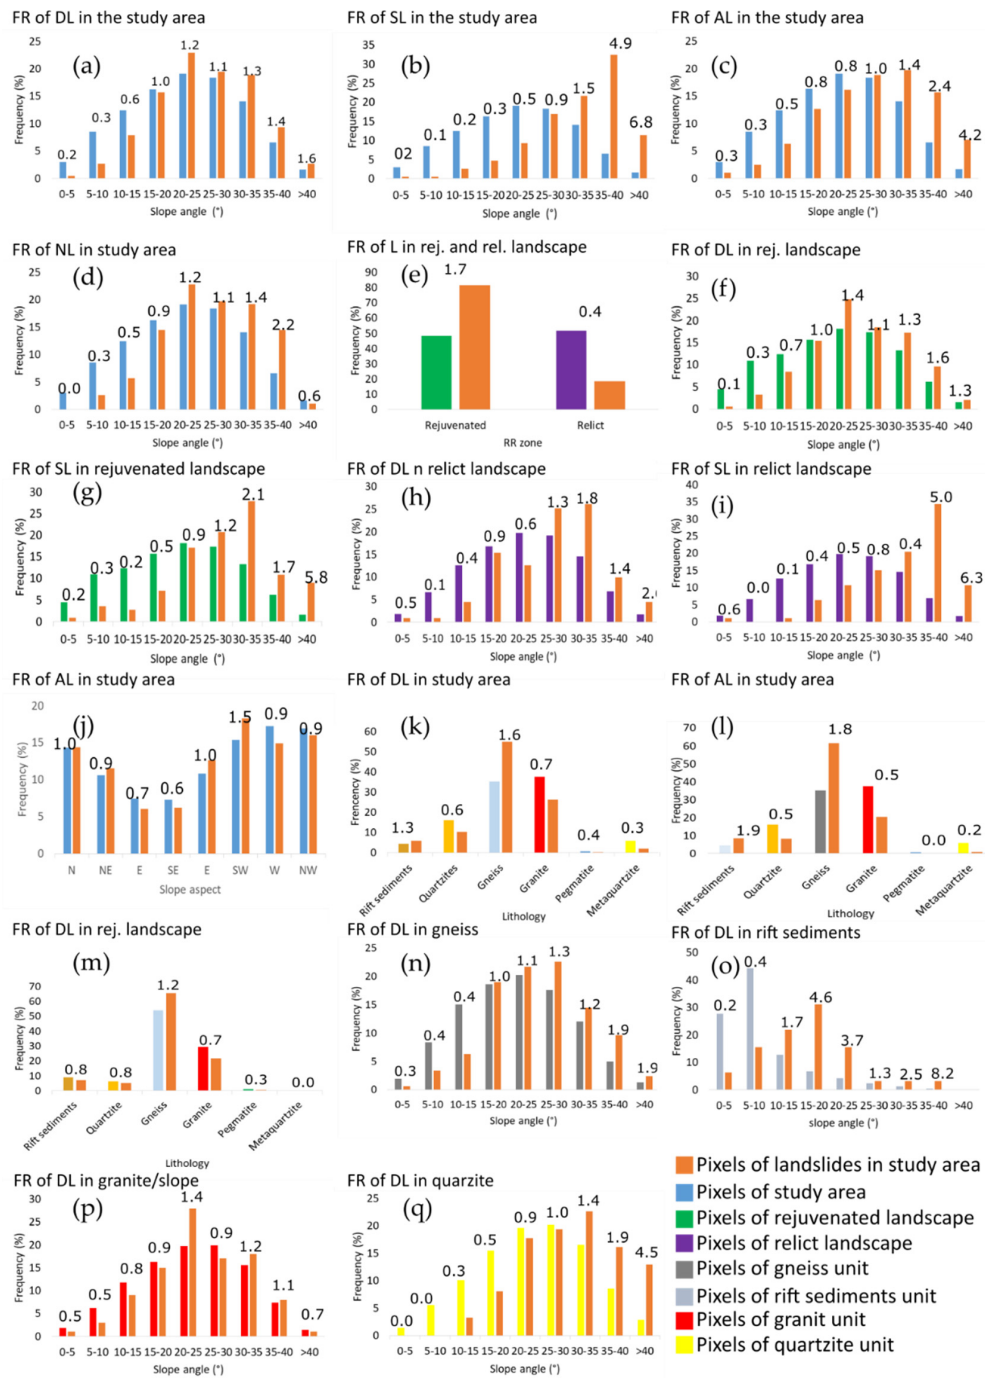
Figure 8. Frequency distributions for landslides (orange bars; each landslide is represented by one pixel over its depletion area) and for all pixels outside the landslide bodies in the entire study area, rejuvenated, and relict landscapes (blue, green, and violet bars respectively). The other bars (grey, blue-grey, red, and yellow) are landslides distributions within the different lithologies; respectively in gneiss, rift sediments, granite, and quartzite. (a–d) Slope angle in study area respectively for deep-seated (DL), shallow (SL), active (AL), and non-active (NL) landslides; (e) landslide distribution within the differentiation of rejuvenated and relict landscape; (f,g) slope angle in the rejuvenated landscape respectively for deep-seated and shallow landslides; (h,i) slope angle in relict landscape respectively for deep-seated and shallow landslides; (j) slope aspect for active landslides; (k,l) lithology in study area respectively for all deep-seated and active deep-seated landslides; (m) lithology in the rejuvenated landscape for deep-seated landslides; (n–q) slope angle respectively in gneiss, rift sediments, granite, and quartzite for deep-seated landslides. For each class, the corresponding frequency ratio (FR) is indicated.

Our data show that the slope angle is the main landslide controlling factor (Table 4). This control is particularly important for shallow landslides. They tend to concentrate on slopes $>25^{\circ}$ (Figure 8) and this effect is slightly more prominent in the relict landscape. Overall, the deep-seated landslides occur on slopes with a lower steepness; yet this control is more important for active, generally smaller, landslides. Rift sediments and gneiss are both favorable to landslides (Figure 8k–m). These two lithologies are the dominant rocks in the rejuvenated landscape (the Rift sediment lithology is found only in this region). Overall, the control of slope angle is larger in these two lithologies (Figure 8n–q). Slope aspect is not significant for the deep-seated landslides and, at this spatial scale of this study,

a link between the presence of faults cannot be highlighted. For the active processes, a small association is observed for south- to south-west-oriented slopes (Figure 8j).

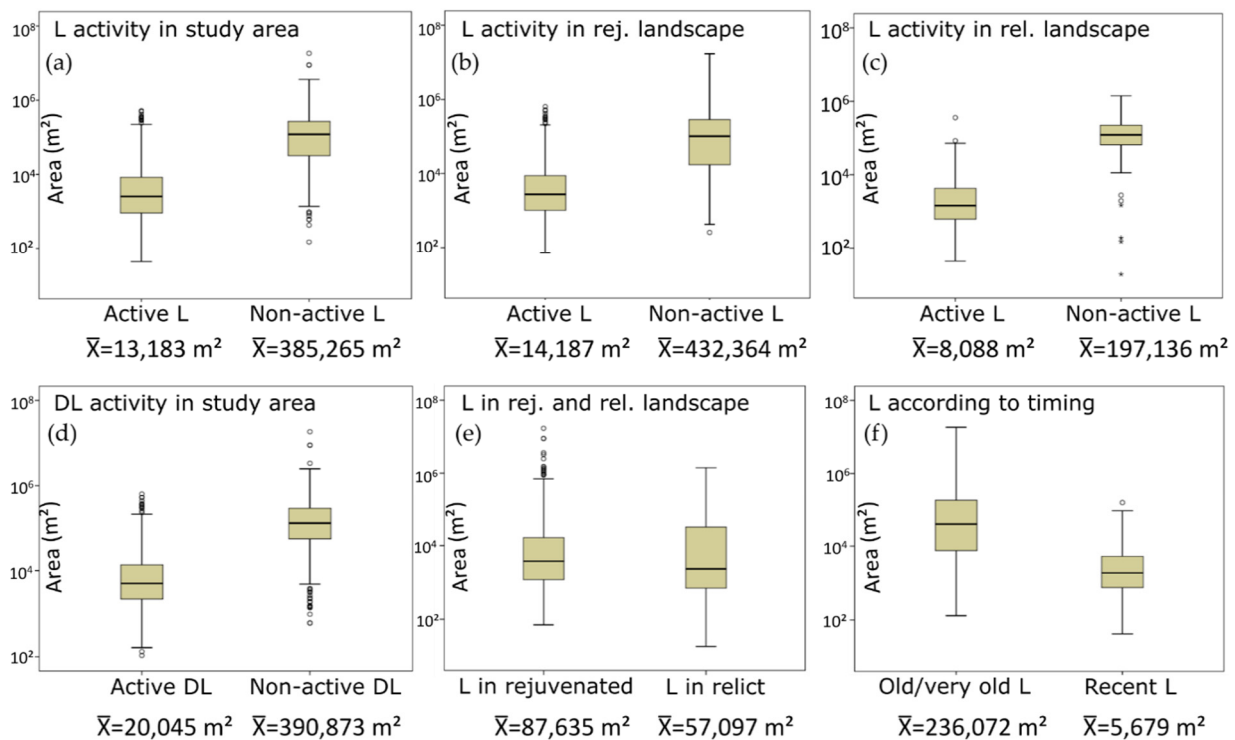
Figure 9. Boxplots showing the distribution of the landslide size (m^2) with regard to landslide (L) activity in (a) the entire study area; (b) the rejuvenated landscape (rej.), and (c) the relict landscape (rel.). (d) Boxplot comparing the distribution of deep-seated landslide (DL) size (m^2) in function of their activity in rejuvenated and relict landscape; (e) boxplot comparing the distribution of the landslide (L) size (m^2) in function of their position in the landscape (rejuvenated (rej.) or relict landscape (rel.)); (f) boxplot comparing the distribution of landslide (L) size (m^2) in function of their age. Boxplots give lower and upper quartiles and median. The whiskers of each box represent 1.5 times the interquartile range. Outliers beyond whiskers are shown as dots. For each boxplot, the average area \bar{X} of the landslides is provided.

deep-seated landslides. Active landslides cover an area of 14.2 km². The analysis of the size distribution shows that landslides are larger in the rejuvenated landscape (Figure 9e). The population differences are much larger when looking at the activity of the landslides; active landslides being smaller whatever position in the landscape (relict/rejuvenated) or depth is considered (Figure 9a–d). The recent landslides are smaller (Figure 9f). Most of largest recent landslides are in the rejuvenated landscape.

The significant difference in landslide size that is observed between active (generally recent) and non-active deep-seated landslides (Figures 2 and 9a–d) could be because the period of observation is too short to capture the impact of high-magnitude triggering events such as large earthquakes [16,71]. In addition, we know that climatic conditions have changed over the past tens of thousands of years [62,72,73]; the climate also being a key driver acting as cause and trigger of deep-seated landslides [40,74]. It is important to note that the size of old landslides, as exemplified for the Ikoma landslide in the neighbor region of Bukavu in DR Congo [40], reflects a history of accumulating slope deformation phases [75]. In other words, the actual size of an old landslide is not necessarily the consequence of one single slope failure associated with one high-magnitude triggering event. The numerous reactivations that we have detected in the region of Bujumbura support this scenario of path-dependency where landslide size grows in time [76].
