River and landslide dynamics on the western Tanganyika rift border, Uvira, D.R. Congo: diachronic observations and a GIS inventory of traces of extreme geomorphologic activity

Abstract Uvira occupies a series of narrow alluvial fans squeezed between the NW corner of Lake Tanganyika (± 710 m asl) and the W-shoulder of the Tanganyika rift, the Itombwe–Mitumba Plateau ($\pm 3,000$ m asl). In 50 years, the fans progressed into the lake over distances up to some hundreds of metres. This happened during a few catastrophic flash floods issued from the torrents which cascade from the rift shoulder with a mean longitudinal gradient of 0.2 m m^{-1} . The last event in 2002 led to the destruction of parts of the town and to some 50 casualties. Landslides occurred in the hills. On the base of stereoscopic interpretation of aerial photographs from 1959, complemented with data from 2000 ETM and 2004 IKONOS imagery, a geographical inventory has been made of strongly incising (10^{-1} to 0 m in 43–45 years) river sections, of all types of landslides and of all tectonic structures, visible in the rugged hinterland of the fans. Traces of active N–S as well as E–W trending faults are present. Some o

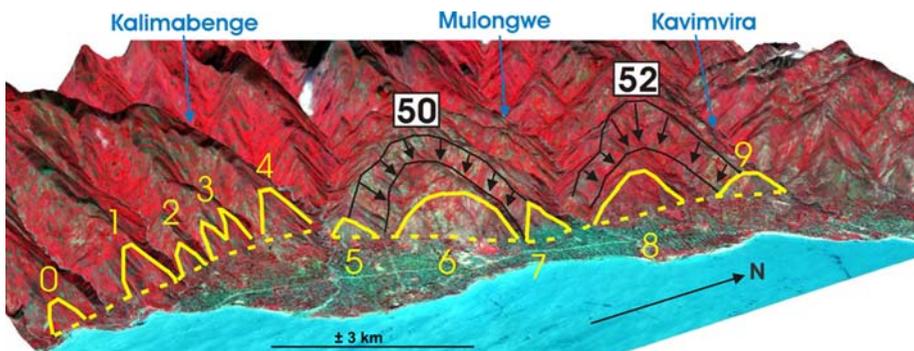
Fig. 3 3-D panoramic view of Uvira and part of the mountain hinterland. Fault facets 0–9 in yellow. The head scars of the ancient mega-landslides 50 and 52 in black. Both landslides have been undercut as a result of the downthrow along fault facets 5–9. IKONOS (bands 4, 3, 2 as RGB) draped on the 30 m SRTM, shown in ENVI, Vertical exaggeration: $\times 2$

Seismic landslides 50 and 52 (Fig. 3) constitute another risk. Because they are cut off along fault facets 5–9, their respective lobes are much shorter than normal. Table 2 shows that the length–width ratio of landslides 50 and 52 belongs to the lowest values of the whole set of mapped landslides. Both slides remain in place without the upslope oriented confining pressure of the lower part of the lobe, tectonically cutoff. Therefore, the remaining upper part of the lobes of landslides 50 and 52 should be in a stability situation lower than normal and seismic events could trigger their movement. The volume of both lobes is estimated as another 10^7 m³.

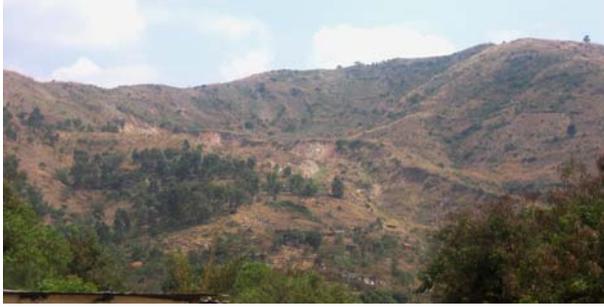
Fig. 5 Kandibula slide remobilisation pictured in 2006
