**Underground timber constructions from the First World War are
well preserved after 100 years**

Paper prepared for the IRG48 Scientific Conference on Wood Protection
Ghent, Belgium
4-8 June 2017

The Memorial Museum Passchendaele 1917 and the municipality of Zonnebeke drained the 'Zonnebeke Church Dugout' recently on September 26th 2016. The draining was part of large-scale scientific research on the possibility to temporarily open this unique underground site for the general public in 2017. The research was done in collaboration with the Flanders Heritage Agency and Archeo7. Because of his expertise in the field of underground structures, also amateur archaeologist Johan Vandewalle took part in this research. On October 1st, Minister-

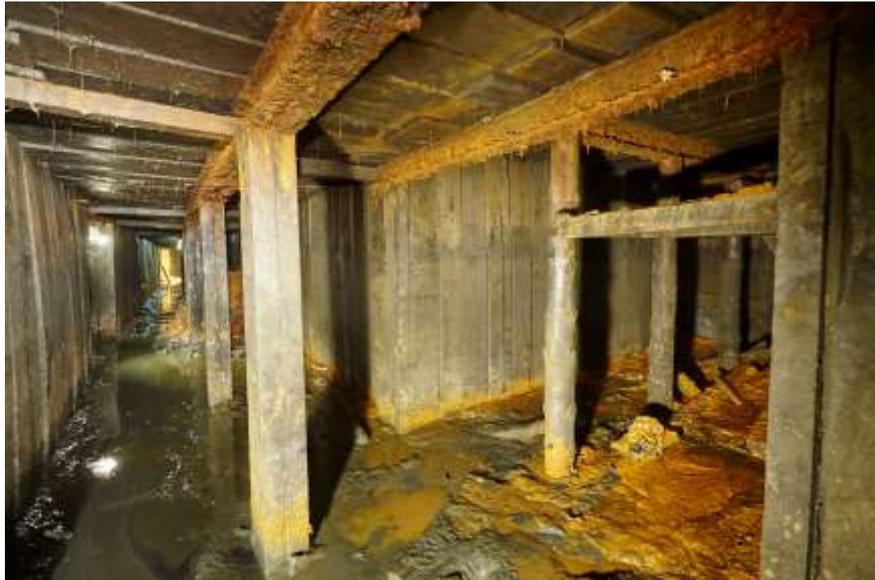
In Figure 3 the central tunnels of the Zonnebeke Church Dugout the wooden construction seems to be intact while most metal beams and connectors show major degradation. The groundwater was constantly at a high level over the past 100 years for most of the World War I underground constructions, though it remains unclear what part of the superficial degradation (Figure 4) is related to the in use period or whether it is related to the last 100 years. Analysis of the decay types present showed features of bacterial while presence of soft rot or even basidiomycetes decay was not found on the samples examined (Figure 5). Total disintegration of the cell wall was observed. Furthermore except for the compound middle lamella and some parts of the S3-layer all former cell layers were substituted by some amorphous residue material.

Figure 3: Central tunnel and adjacent room equipped with the remains of racks used as bedding for military in the Zonnebeke Church Dugout, 100 years after its construction by Canadian and Australian Tunneling Companies (photo K. Vandevorst - Flanders Heritage Agency)

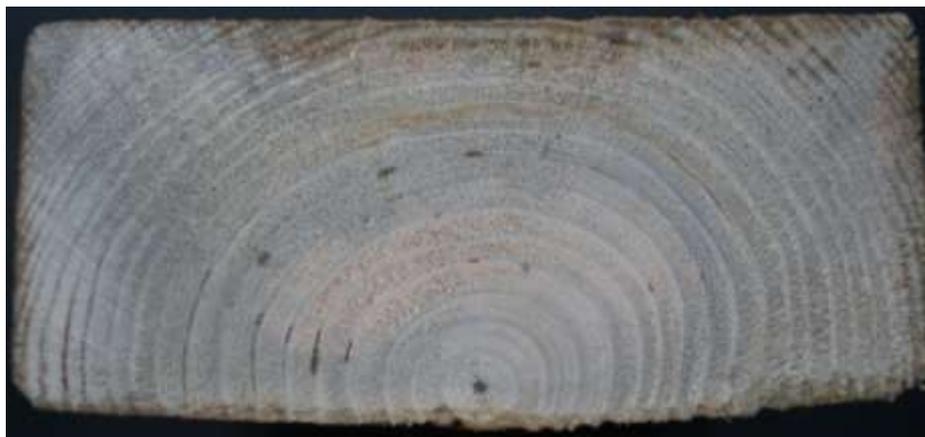
Figure 4: Cross section of a beam extracted from the Zonnebeke Church Dugout, showing a limited zone of degradation.

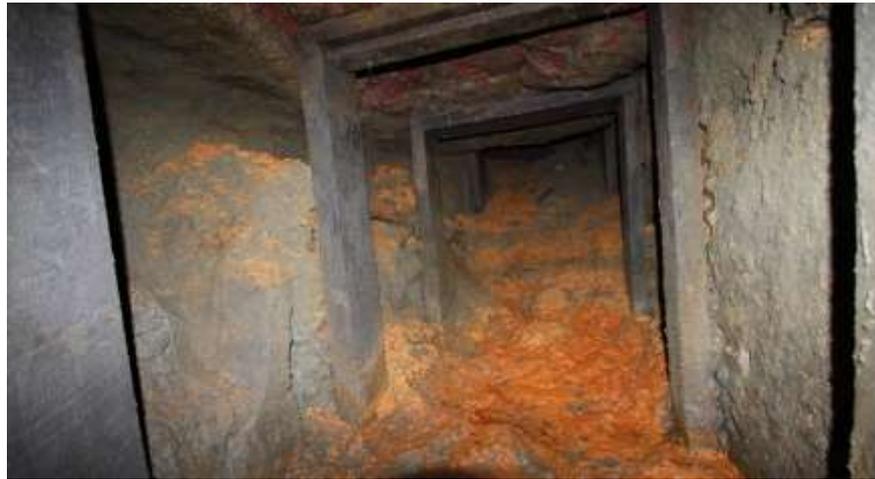
Figure 7: Vertical soil between 2 wooden frames in an unfinished tunnel of the Zonnebeke Dugout (photo Ingenieursbureau Norbert Provoost bvba)
